F-31 Float Bow Collisions

The Damage Possible, and How To Minimize

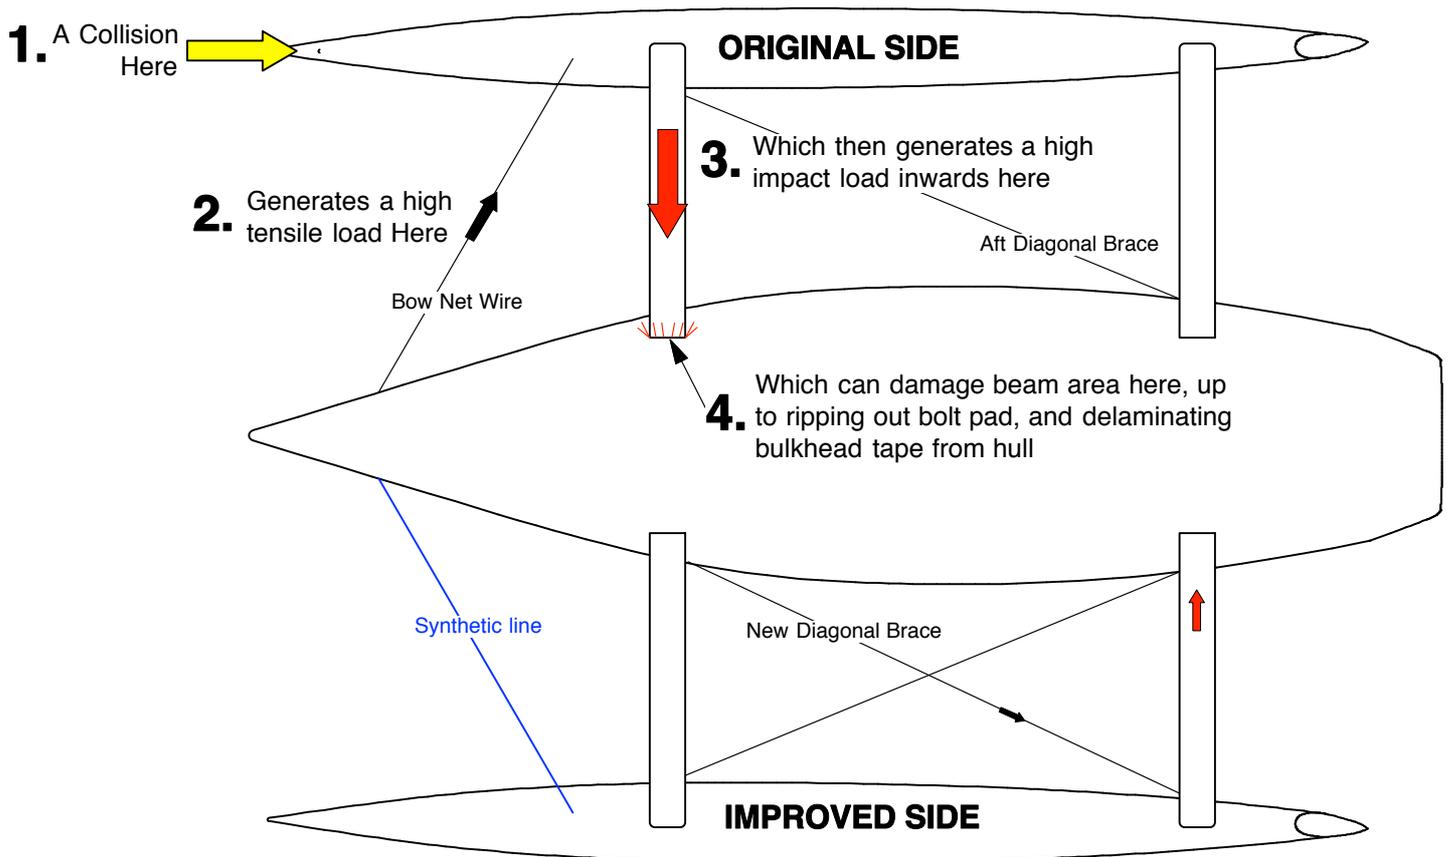
The F-31 can suffer damage at the forward beam inner end and/or the beam bulkhead area as the result of an aftwards float bow collision. Damage can also appear much later, due to a weak point having been created from a collision at some earlier time.

A float bow collision can result in a sudden inwards impact on the forward beam, which is generated by the forward diagonal wire brace used at forward edge of F-31 bow nets built in 2000 or earlier. This diagonal wire will turn the aftward impact inwards, and into the forward beam, as shown above on upper (starboard) side.

Damage from collisions can be minimized by replacing bow wire with a more stretchy synthetic, and adding a wire brace further aft, which will reduce impact load, and direct it through the less loaded aft beam area instead.

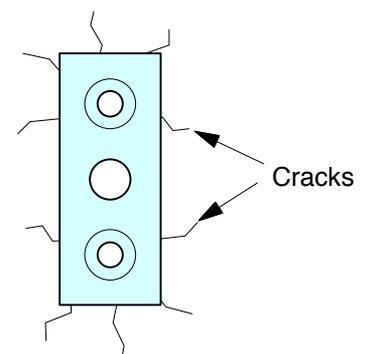
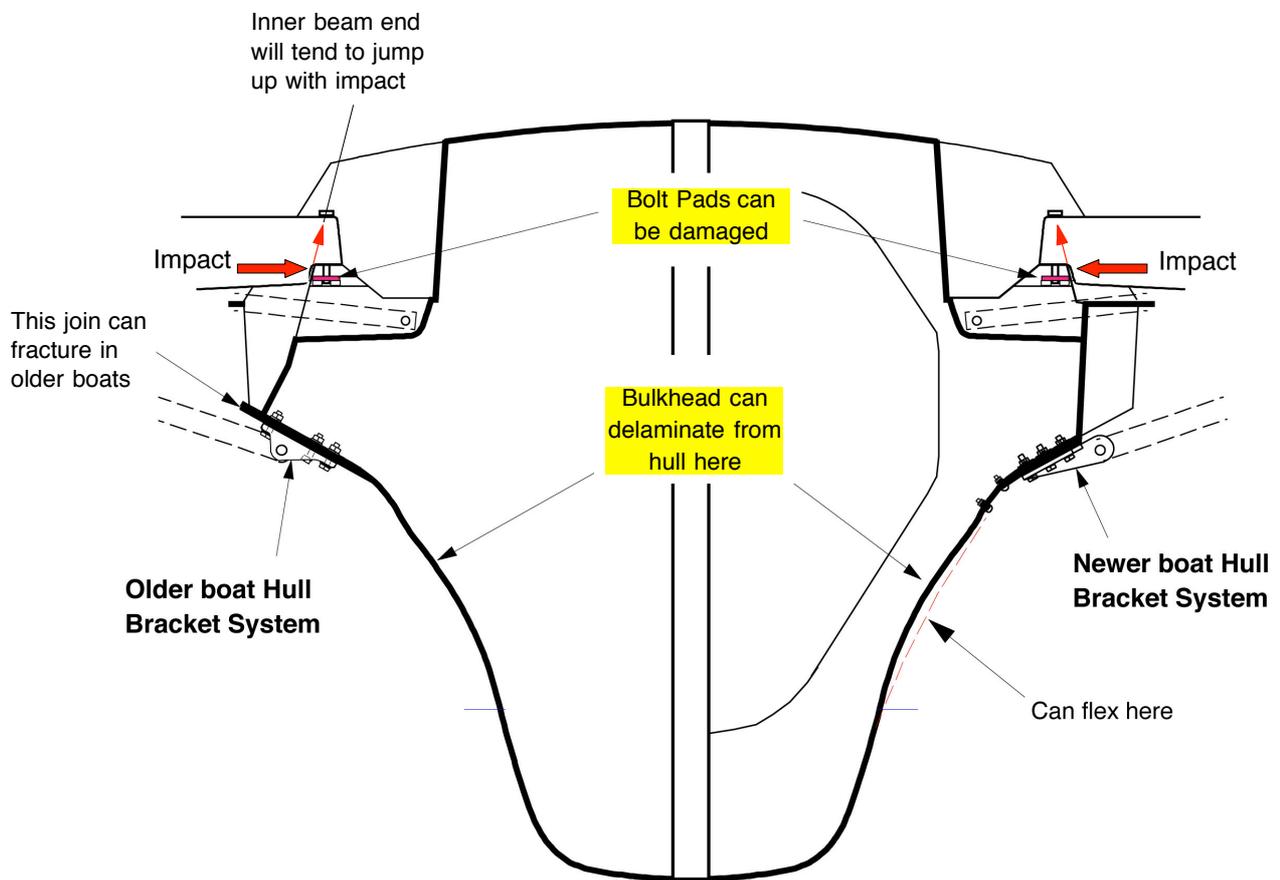
BEAM BOLT PADS: Beam bolts screw into these stainless steel pads/plates and they are normally not under much load in normal sailing, but can be damaged in a fore and aft collision, even to being pulled right out. They should be regularly checked on the exterior for any star cracks emanating from around the bolts as these will indicate a likely collision at some time. If such cracks can be seen, then forward beam bulkhead taping to hull must also be checked carefully, as this is the next failure point.

BEAM BULKHEAD: If collision is severe enough, the fiberglass tape holding the Forward Beam Bulkhead to the hull can delaminate from hull, so this area must be checked closely, details of where are on next page.

There is no 'fix' as such needed, other than don't hit anything with a float bow. However, a way to avoid any problems with older boats is to replace the wire bow braces with more stretchy synthetic lines, and then add new wire braces from the forward beam area on main hull to the floats at the outer end of aft beams, as is standard on newer boats. This new aft brace is at a much more effective angle, and will divert any collision loads (much reduced) into the aft beam area which is more able to absorb them.
